Manhole Inspection Summary

Manhole # S19II_012MH

Location Address: **2019 WESTWOOD AVE**

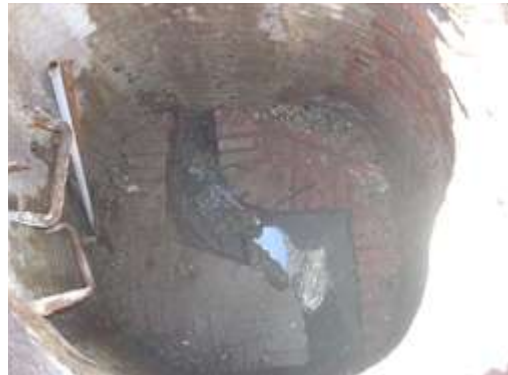
Top View

Condition: ☐ Sound ☐ Cracked ☐ Root Intrusion ☐ Deteriorated ☐ Leaks ☒ **Debris**

DEBRIS ON CHANNEL

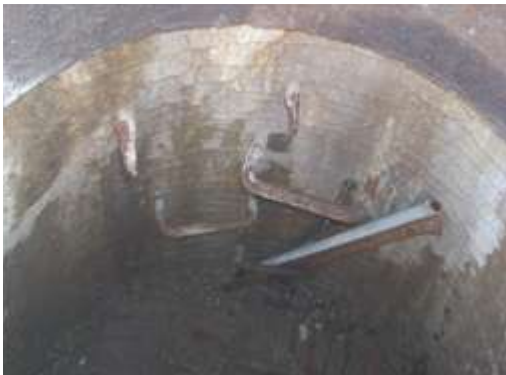
Defect 2

Steps Count: **3** Missing: **1** ☒ **Corroded**

MISSING AND CORRODED STEPS

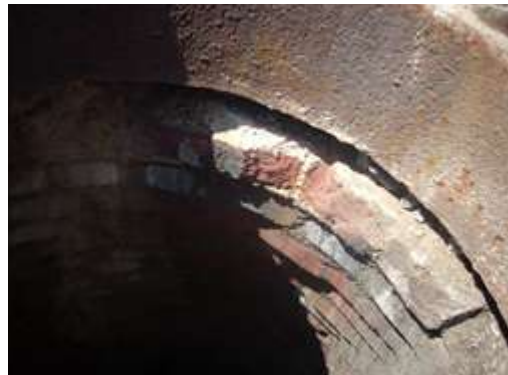
Defect 1

Condition: ☐ Sound ☐ Cracked ☐ Root Intrusion ☐ Loose Brick ☒ **Deteriorated**

DETERIORATION OF CHIMNEY

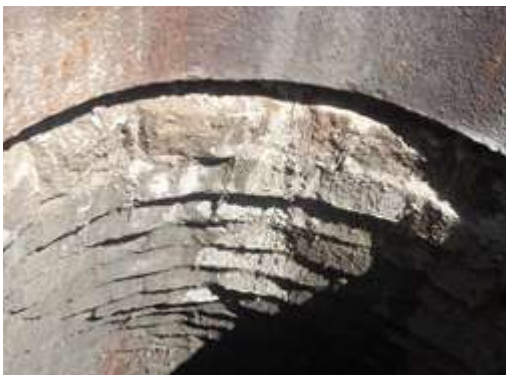
Defect 3

Infiltration: ☐ None ☐ Joint ☐ Cracks ☐ Mortar ☐ Roots ☒ **Wall**

INFILTRATION OF CHIMNEY

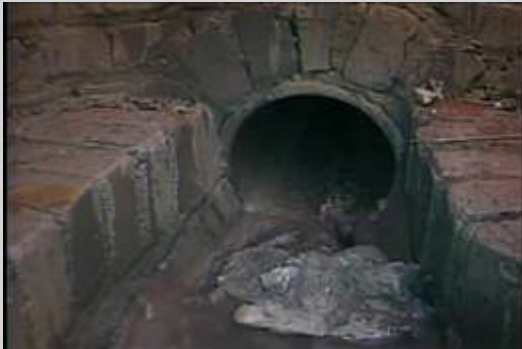
12 O'Clock Outflow

DEBRIS ON CHANNEL

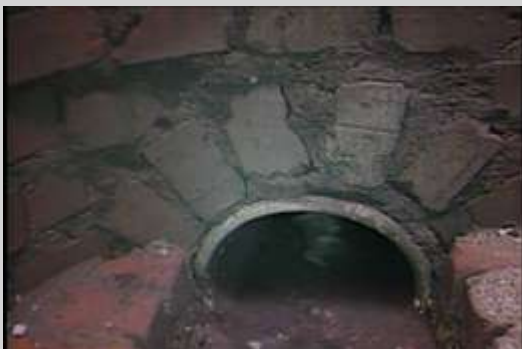
6 O'Clock Inflow

Pipe Height: **7.2** (in.) Rod and Bar (Angled)
Pipe Material: **Clay** ☐ Pipe Lined
Invert Depth: **8.46** (ft.) Flow Characteristics: **Slow**
Deposits: ☐ None ☐ Mud ☐ Sludge ☒ **Debris** ☐ Grease
Silt Depth: **2** (in.) Deposits Extent: **Light**
Infiltration: **None** Pipe Seal Cond: **Sound**
